POWER QUALITY

Copper-based Grounding System Ends Lightning Damage at Florida Resort

**\$3,500 Invested in
Grounding System Upgrade
Protects \$1.5 Million in
Communications, Computers**

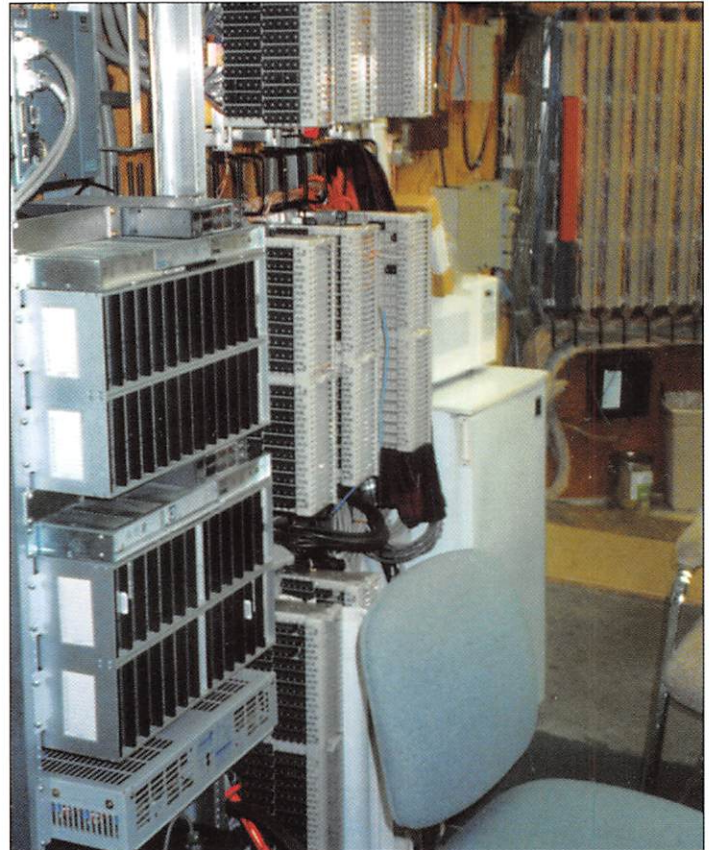
Figure 1a. Some communications equipment at Resort World. At the time of the 1998 lightning strike, Resort World's system was connected to 540 lines. (It has since been more than doubled.) Lightning did \$70,000 in damage to the equipment, including modems, multiplexers and computers. The facility's original telephone switch, costing \$160,000, was also destroyed.

"Our communications office was connected to more than 540 lines at the time (**Figure 1a**). We thought we were adequately protected by the grounding system that had been installed when the resort was built back in the mid-1980s; after all, it met the national and local electrical codes. However, the resort has been upgraded continuously and our communications systems have grown a lot more sophisticated. I didn't realize it at the time, but our old grounding and surge protection system just wasn't able to protect the new equipment we'd installed.

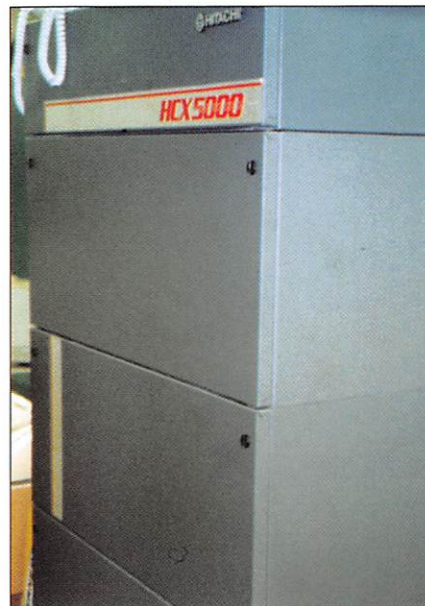
Figure 1b. Resort World's new Hitachi telephone switch cost more than \$500,000. With such expensive electronic equipment at risk from lightning damage, the resort's insurance carrier insisted that the grounding system be upgraded. The upgrade, designed by Power & Systems Innovations, Orlando, relies on low-resistance grounding electrodes, an extensive network of heavy-gage copper grounding conductors and properly grounded transient voltage surge suppressors.

"We had to replace a lot of equipment at Resort World. At the same time, we needed to install a larger switch to handle all the phone and data lines being added to the resort, so we upgraded to a CHX 5000 (**Figure 1b**). It cost us a half million dollars, and we were really afraid we might lose it if we took another big hit."

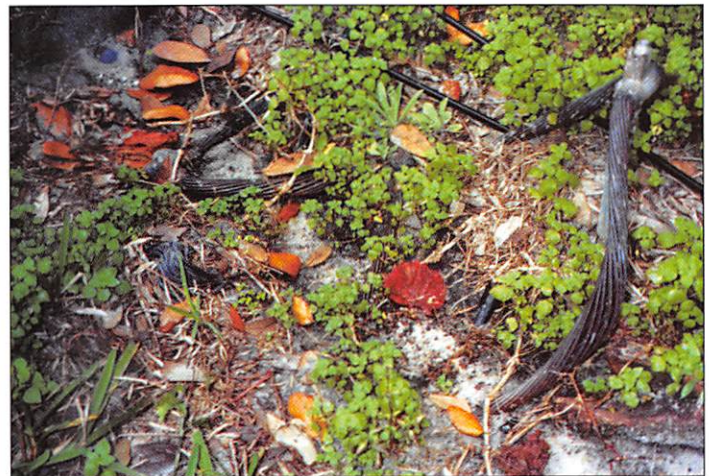
Figure 2. One of numerous grounding electrode conductors installed by PSI at Resort World. The 4/0 conductor at right leads to six 50-ft (15-m), 3/4-in (19-mm) diameter copper-clad rods set in a row running parallel to the rear of the resort's communications and computer offices, about 12 ft (4 m) from the structure. The conductor leading to the left tags onto one of the building's original 10-ft (3-m) electrodes. In accordance with PSI specifications, ground resistance of all new electrodes is less than five ohms.

"At Resort World, we installed six 50-ft (15-m), 3/4-in (19-mm) diameter copper-clad rods in a row running parallel to the rear of their communications and computer offices, about 12 ft (4 m) from the structure. We had to go down 50 ft (15 m) in order to get below five ohms. One of those electrodes was driven near the emergency generator we'd installed earlier. Next, we connected the electrodes using 4/0 AWG stranded copper cable, exothermally bonding every joint. We also bonded to the fence surrounding the generator and tagged onto the existing electrodes (**Figure 2**). When we were through, resistance had dropped to less than four ohms; that's more than 100 ohms lower than what they had before!

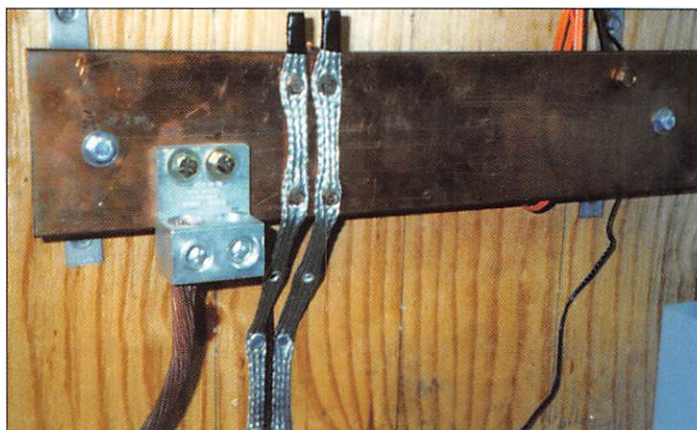
Figure 3a. (above) Copper ground plate connecting incoming grounding electrode conductors (tinned copper lightning cable) with bare 4/0 copper used as a halo ground. The halo ground is also bonded to other ground plates, as shown in **Figure 3b**.

"We ran the 4/0 copper into and around the inside of the Resort World's offices. This arrangement is called a 'halo ground.' It's very effective. On this particular job, we ran the cable along the walls, about six feet up. We bonded 4/0 copper from the halo to the neutral-ground connection at the service entrance by way of copper ground plates mounted on the wall and lengths of 29X lightning cable¹ (**Figure 3a**). The ground plates were connected with 4/0 copper, and connected to smaller tinned-copper bus strips from there to panels serving the MIS equipment, as well as the equipment itself, using #4 AWG copper (**Figures 3b, 3c**). All turns in the grounding cables are generous: our specs call for sweep

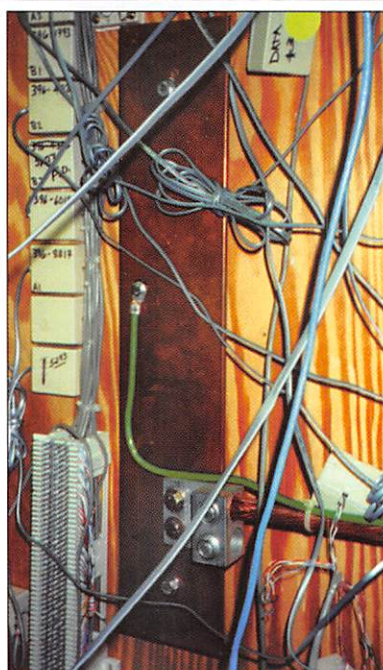
Figure 3b. (left) Copper ground plate used to connect 4/0 bare copper halo ground (lower right) with grounding connections (green wire, among others) leading to electrical panels and telephone equipment. The use of ground plates such as this one simplifies the design and installation of the grounding system and ensures that all grounding connections remain at the same potential.

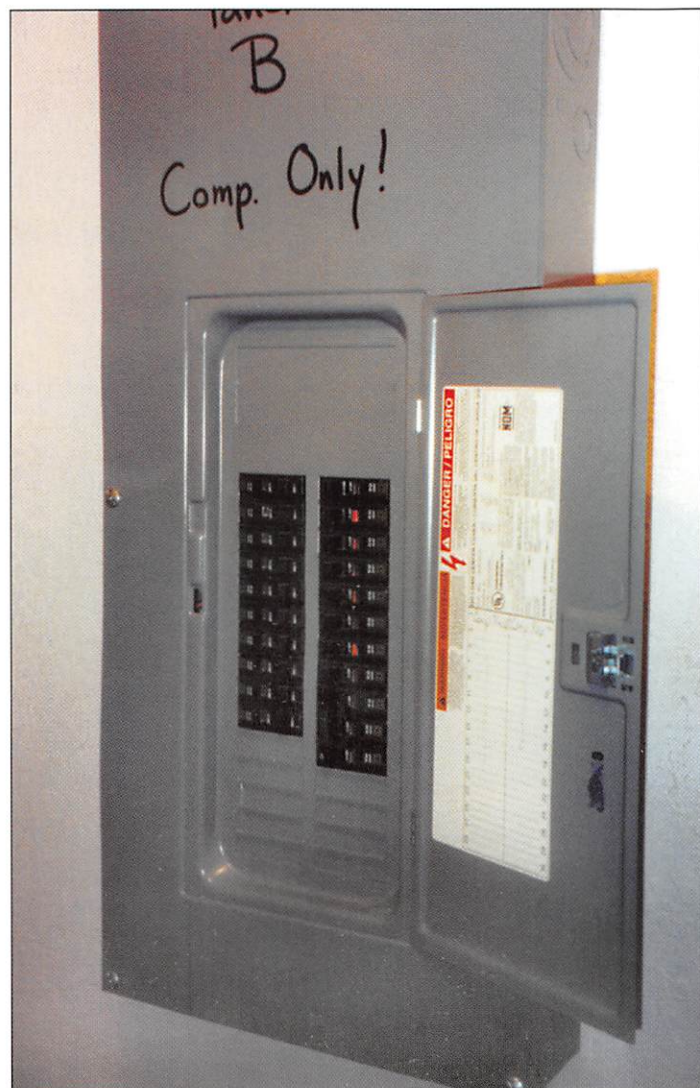
Figure 4. IEEE Std. 1100 and other publications strongly recommend that sensitive electronic loads such as those involving computers, communications and control equipment be served by separate branch circuits from those used for conventional electrical loads. At Resort World, PSI placed all such circuits on separate panels, going so far as to mark junction boxes to avoid the chance of mixed loading in the future.

"First, we made certain that sensitive electronic loads were served by separate branch circuits (**Figure 4**). Then we installed a transient voltage surge suppressor (TVSS) at the service entrance panel, two at the UPS transfer switch, and one at each panel serving communications equipment (**Figures 5a, b, c**). The TVSS units we call for provide full-mode protection: ground-to-neutral, ground-to-phase, phase-to-neutral and phase-to-phase. If you think about it, that's the only type of suppression that protects the system in the event any conductors are lost. A good TVSS unit will also provide EMI/RFI filtration, but no matter what type it is, it *must* be properly grounded to a low-resistance grounding circuit. If the TVSS doesn't see a low-resistance ground, there's a chance a surge will get past it.

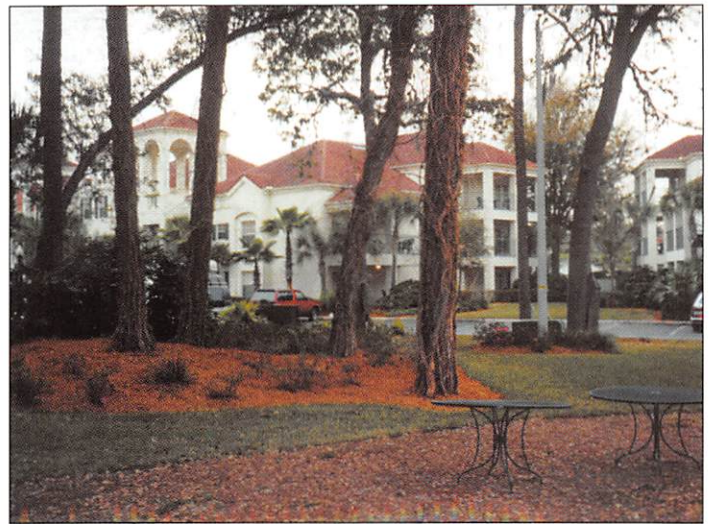
Figure 6. The Star Island Resort, located adjacent to Resort World in Kissimmee, Florida, also suffered costly lightning, and power quality-related damage, including destroyed communications gear and burned-out swimming pool motors. There has been no further damage at the resort since PSI installed a low-resistance copper grounding system.

upgraded the grounding system at their communications offices, one of their clubhouses, the guard shack and the reception center (**Figure 6**). We used to lose computers and telecommunications equipment at Star Island regularly due to brownouts and surges, and we replaced swimming pool pump motors costing \$500 apiece two or three times. We don't have to do that anymore."

And for good reason: all vulnerable equipment is now positively grounded. Because a lagoon separates several buildings, PSI couldn't install a ring ground. The problem was overcome by simply running 4/0 grounding cable through the lagoon. The body of water helps ensure low ground resistance.

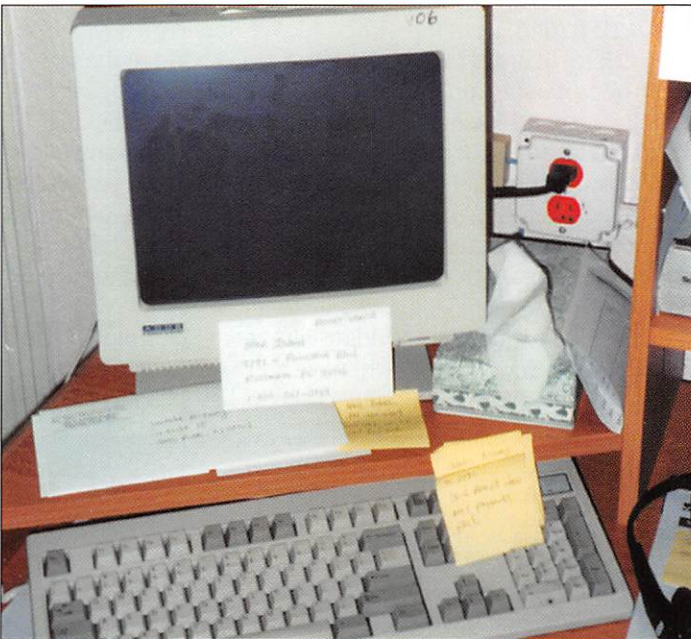
Figure 7. A typical workstation in the construction office that technicians at Resort World call "Hell House" for its many power quality-related problems. The problems are a thing of the past, since PSI installed grounding electrodes having less than 4 ohms ground resistance, plus TVSS protection and dedicated circuits for sensitive electronic equipment. In addition, PSI specified isolated grounds for the sensitive circuits, as can be seen by the orange-colored outlet shown in the photo. Finally, PSI specified that branch circuits serving sensitive electronic equipment must contain no more than two outlets each. Among other benefits, limiting the number of outlets per circuit reduces the magnitude of harmonic currents on neutral conductors.

Padgett continued, "We also have a construction office that serves both Resort World and Star Island. We fixed or replaced equipment there so often we started calling the place 'Hell House.' It houses computers for about 25 workers, a laser printer and the usual office equipment (**Figure 7**)."

John West recalls the structure. "The building sits near a stream and right next to a wetlands area. Before we were called in, the building had a shallow grounding electrode near the service entrance, but despite the wet ground, resistance was higher than 100 ohms. We drove a deep electrode at the service entrance and one more 30-ft (9-m) electrode right at the edge of the wetlands. Ground resistance dropped to less than four ohms.

"We also installed full-mode TVSS protection at the building's main and branch circuit panels and pulled isolated grounds (IG) for each circuit serving computers, faxes and printers. We specified a maximum of two outlets per circuit. Some people might consider that excessive protection, but
